TLC BEFORE

AFTER—as of SEPT 2010

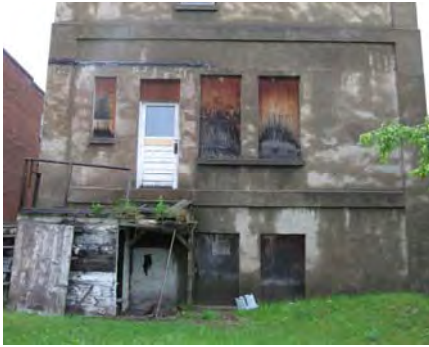
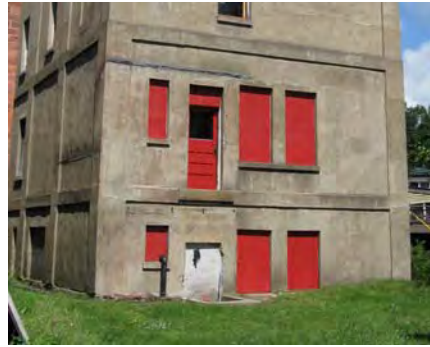
Asbestos removed from windows, floor tiles, ceiling plaster.

Basement cleared of all debris, Exterior Shed removed, Temporary red paint on plywood window coverings to cheer up back of building while under construction.

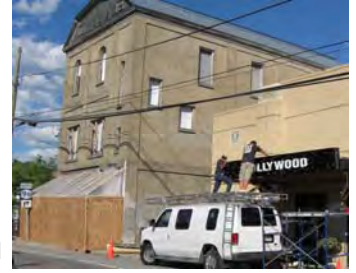
TLC Main St construction shed , new opening, tin ceiling detail

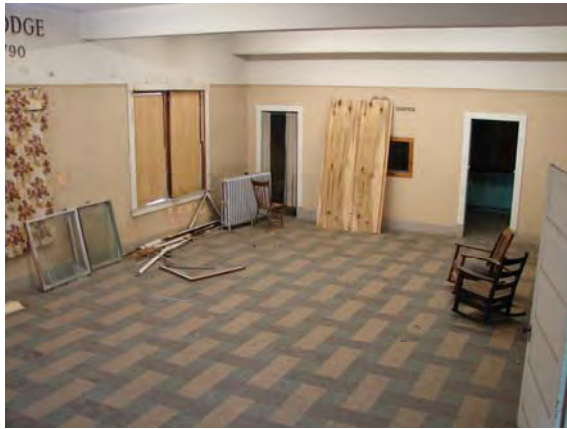
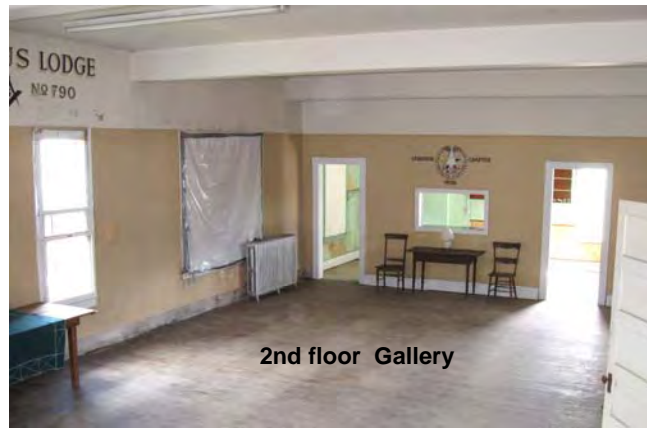
2nd floor Gallery

2nd fl Gallery—cleared, temporary window lights installed

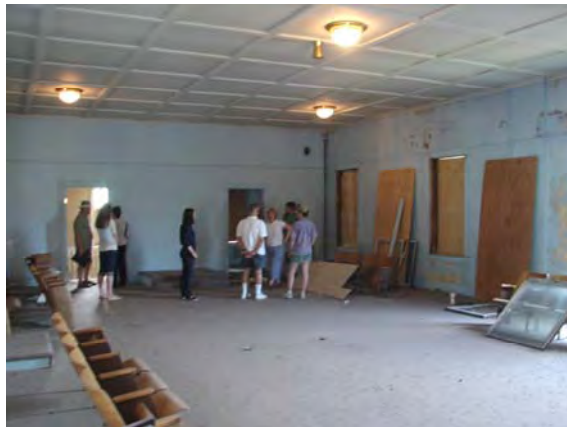
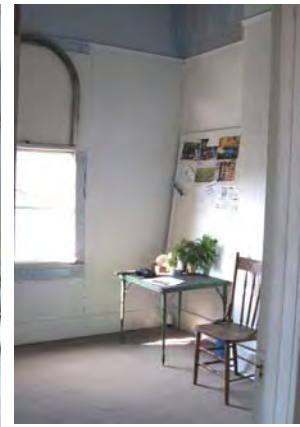
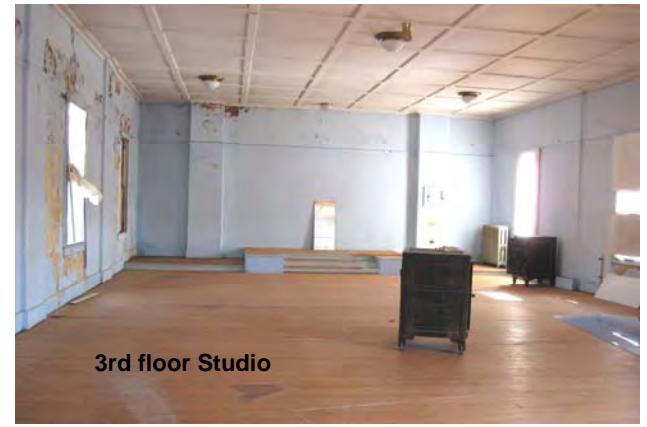
3rd floor Studio

3rd fl Studio—cleared, temporary windows installed for air and light; 3rd floor office area painted.

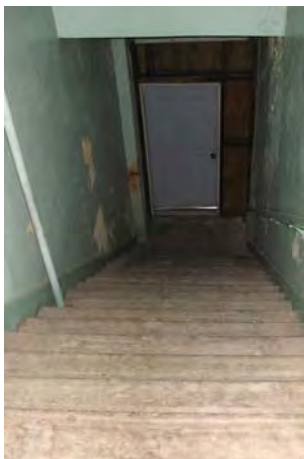
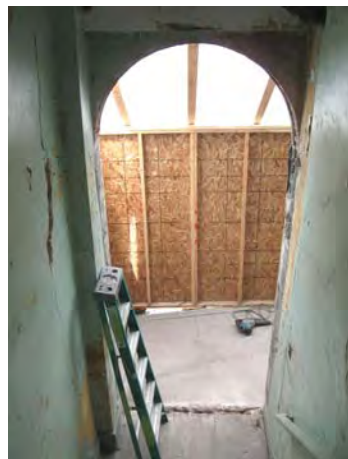
Third floor Studio now cleared, office space cleared, above. Stairwell, new door, with restored arched light, under construction below.

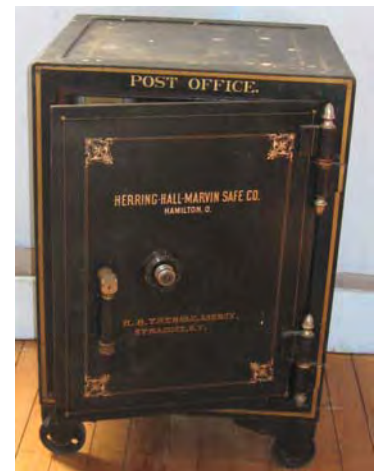
two extremely heavy safes to remove from the middle of the third floor. IDEAS?
